Optimizing Mitigation Measures against Slush Flows by Means of Numerical Modelling

- A Case Study Longyearbyen, Svalbard -

Árni Jónsson^{1*}, Peter Gauer¹

¹ Norwegian Geotechnical Institute, Dept. of Natural Hazard (Sognsveien 70, NO-0806 Oslo)

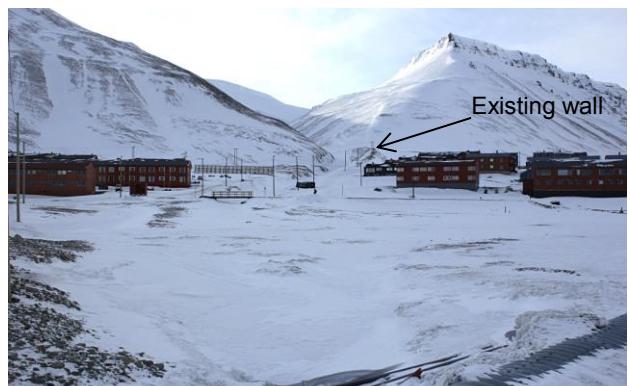
Fig. 4 Vannledningsdalen seen from the main road. The slushflow in January 2012 spread out on the open area in the front.

Late in January 2012, a warm weather spell with precipitation caused a slushflow from Vannledningsdalen (**Fig. 4**) into the canal on the alluvial fan (named "Haugen") and down to the main road to the settlements of "Nybyen". At this time, the flow did not hit or damage any inhabited house on the alluvial fan.

The bedrock in this area consists mostly of sedimentary rock types like sandstone, siltstone and shale. The landscape is characterized by layered mountains with a plateau on top and U-shaped valleys formed by glaciers. Vannledningsdalen ("water pipe valley") is V-shaped (**Fig. 3** and **Fig. 4**) and it forms a scar in the mountainside. It is mostly shaped by erosion after the last glaciation; the eroded material built up the fan below. There are steep flanks on the orographic right side and more gentle slopes on the left side. The left side has abandoned coal mines at ca. 280 m height above sea level.

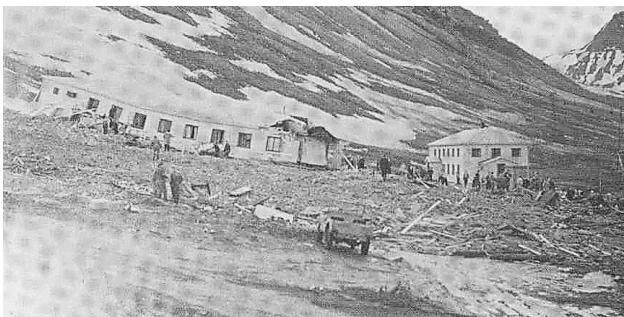
Fig. 5 Buildings on Haugen that were hit and destroyed by slushflow in 1953. (UNIS, 2006).

The NGI report from 1990 states that meteorological- and historical data indicate that larger slushflow events than the ones in 1953 (Fig.5) and 1989 can be expected from Vannledningsdalen.

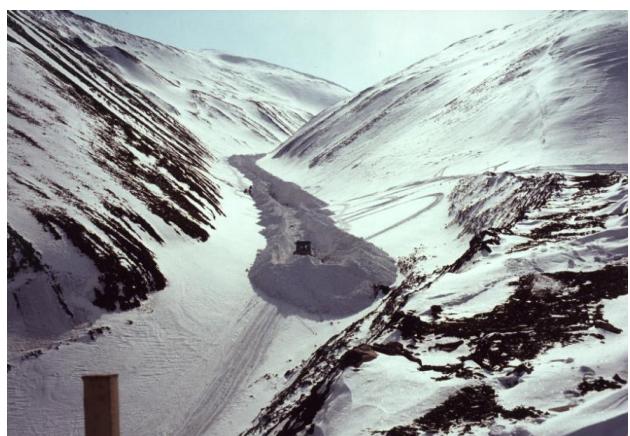
Fig. 6 The figure shows how the snowpack in Vannledningsdalen was prepared to minimize the slushflow risk. This method is still used today.

Shortly after the incident in 1953 the stream on the alluvial fan was channeled and small walls on both sides were erected past the settlement. A routine for draining the snow with bulldozer from the fan up to the plateau was also established, (**Fig 6**).
