The Landslide Occurred at Kokugawa Area Itakura-ku, Joetsu City

Ami YOSHIDA,^{1,*} Yoshihiko KOIZUMI¹

¹ Erosion Control Division, Public Works Department, Niigata Prefecture Government, Japan

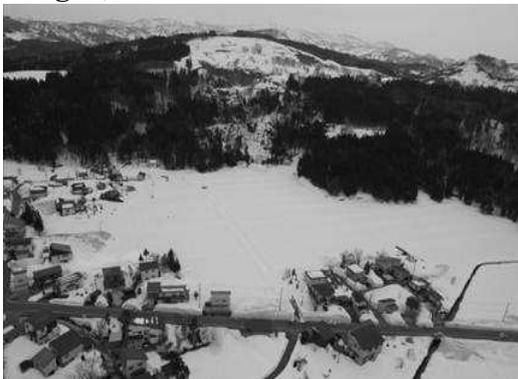
Fig. 2 The landslide at 16:00 on March 8, 2012

The movement of the Kokugawa landslide became active from the afternoon on March 7, 2012. The size of the landslide is width 150m, length 500m, thickness 20m and volume 750,000m³. And the size of the toe of the landslide is about 120m width, 250m length, and 7m thickness. And 5 houses (1 vacant), 4 huts, 2 garages were completely destroyed. A prefectural road and an irrigation canal with irrigated area of 2000ha were cut off, as shown in Fig. 2, 3.

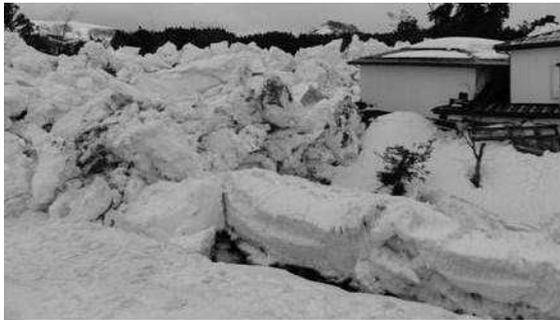
Fig. 4 The landslide reached the house
Sekiyama (Myoko, Niigata)

The movement of the landslide became active since the evening of March 8. Then 1.5m of snow-pack remain at the foot of the slope where the landslide occurred. The snow-pack push by the landslide started to heave and progress, as shown in Fig. 4. Because the movement of the landslide was very slow and the landslide mass was covered with thick snow-pack, its

movement was not readily apparent. We could know it by the sound of falling down tree around the landslide area.

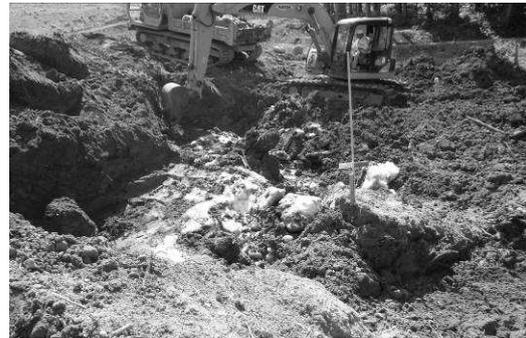
Fig.6 Lump of snow contained in the clod of the landslide

The fundamental geology of this area is composed of the Sugawa tertiary formations. Joetsu City is known as one of the heavy-snow region in Japan. At the time when the landslide occurred, thicker snow cover than usual year remained around the landslide area. It is presumed that much snowmelt water infiltrated into the block of landslide near the sliding cliff induced the landslide.

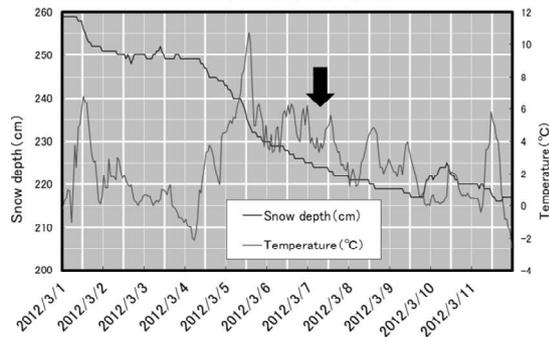
Fig.5 Relationship between temperature and snow-depth near the landslide area

Fig. 5 show the change of snow-depth and temperature during the period before and after the landslide occurrence. The temperature exceeded 10 degrees two days before the occurrence, and the snow-depth decreased rapidly. This result supports the presumption that a lot of snowmelt water was one of the major occurrence factors of the landslide.
