# Distributed acoustic monitoring to secure transport infrastructure against natural hazards - requirements and new developments

## ABSTRACT

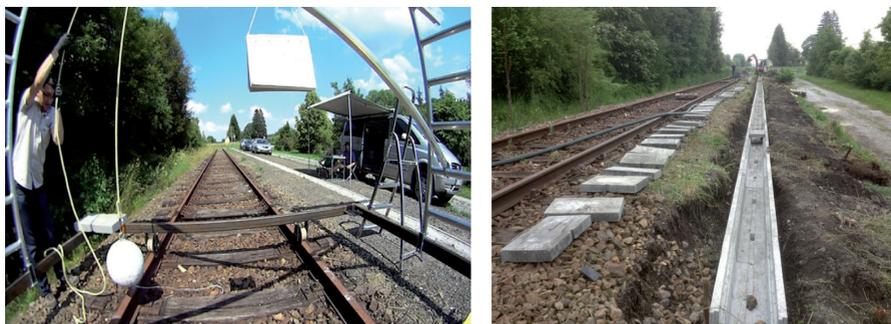
Figure 2: Left: impact on rails with a granite bowl from a predefined drop height. Right: Installation of cable trough according to OEBB regulations for the field experiments.

The objective of these experiments was to analyze the signal and in particular the frequency band of different kinds of rock fall impacts under known conditions and to evaluate the performance of different cable placements. Using this information, a preliminary definition of detection parameters was carried out and preliminary recognition patterns, so called “events”, were defined. For this purpose a 150 m long privately owned shunting track was adapted. Both sides of the track were equipped with different cable layout according to OEBB regulations. One was set up as underground cable, one was placed inside the newly build cable trough and a third one was directly attached to the rail. Then impacts by objects with various weights and materials were induced and their different signals were analyzed (Fig.2). The field experiments lead to the result that the optimal frequency range for rock fall detection is between 100 Hz and 500 Hz. For these frequencies, a pulse rate of 4 kHz delivers an optimal relation between detection range and sensitivity. The variable resonance behavior and frequency domain of rails, ties, ballast and foundation can be utilized for improved event discrimination along the track. However, with a single cable layout no reliable detection crosswise to the track axis is possible. That is because at the same distance to the fiber, direct impacts on the rail may result in higher signals than collisions on foundation or adjacent ground. Here fiber optic cables directly mounted at the rail may be a promising alternative as they enable a better discrimination between direct rail-track impact and ballast impact due to different signal attenuation.

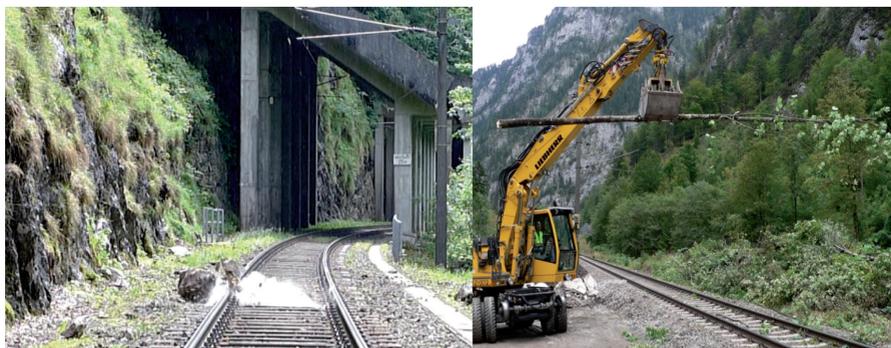
Figure 3: Left: Rocks thrown down on railway tracks. Right: Simulation of tree-fall using an excavator.

After the field experiments full-scale tests on an operating railway line (Hieflau – Admont, Styria, Austria) were carried out. This line is a 40 km single track, with approx. 280 trains/month. This alpine type track is characterized by 4 bridges and 4 tunnels as well as different types of fiber optic cables and different laying systems (earth-based or overhead). One fiber of an operating telecom fiber optic cable was connected to the interrogator unit and signals of artificially produced tree- and rock falls were analyzed. The goal was to gather data on a railway track in operating state and redefine the preliminary detection patterns under realistic conditions. Therefore 30 rocks of different size (up to 50 kg) and shape were thrown down a wall and an excavator was used to simulate around 20 tree-falls (Fig. 3).

The full-scale tests showed that rocks of 20 kg or more and a dropping height above 10 m can be easily identified along the railway axis, but a precise definition of drop height and weight cannot be achieved. For the tree-throws the characteristic frequency spectrum is similar to rock fall but has less energy. They can be identified, if the drop height is higher than 4 m.
