Extreme flash floods in October 2014 and neglected torrent control - case study of the Hotovlja valley, Slovenia

Jošt Sodnik, MSc¹; Pavel Debeljak, Univ. Diploma in WMCE¹; Jure Bogataj, Univ. Diploma in WMCE¹; Urška Petje, MSc¹

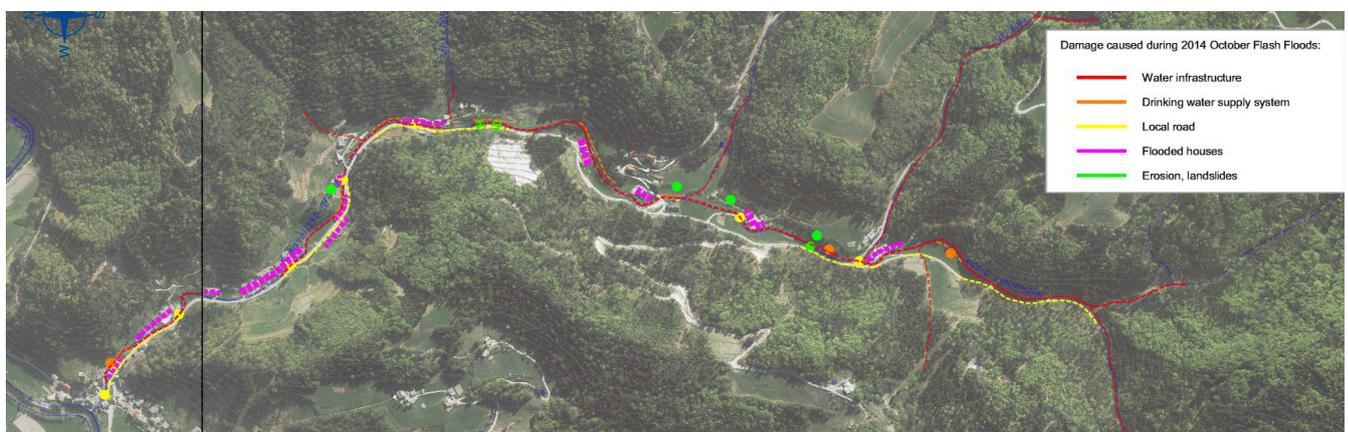
Figure 1. Map with damaged areas

With this extreme event, all the mistakes in spatial planning, bad decisions in the past and at most, lack of regular field inspections and sufficient water management activities such as regular executing of maintenance works in the past decades, came with the price. In the Hotovlja valley, the damage on water infrastructure only was estimated at 1.6 million € and the restoration costs are estimated at 2.94 million €; to this sum the damage on other infrastructure (drinking water supply system 90,000€, local road 320,000€, private property 200,000€) should be added. During the last two decades, population in the valley was growing hence the narrow topography of the valley led to the fact that the Hotovlja torrent channel was narrowing and the channel banks became very useful area for building different kinds of structures, such as courtyards or parking lots. There are two cases where garage and one auxiliary facility are actually built over the watercourse. There are many small private bridges which were built without any expert opinion or proper design on the basis of a hydraulic analysis. Most or all of these bridges and footbridges do not have sufficient opening for real flash flood peak discharges. In a combination with woody debris this is a winning combination for a disaster. Woody debris has become even a more important factor because of very extreme sleet event in Slovenia in February 2014, when over 50% of the Slovenian forests were damaged to a certain degree. Due to slow countermeasures in forest restoration, a lot of fallen trees and dead wood is still in headwaters and torrential channels. These conditions in a combination with an extreme rainfall event led to local but massive torrential flood disasters.
