Characteristics of a Landslide Occurred in May 2015 in Mt. Hakusan and its Influence on Downstream System

Key words: Mt. Hakusan, Tedori River Basin, landslide, turbid water, countermeasure

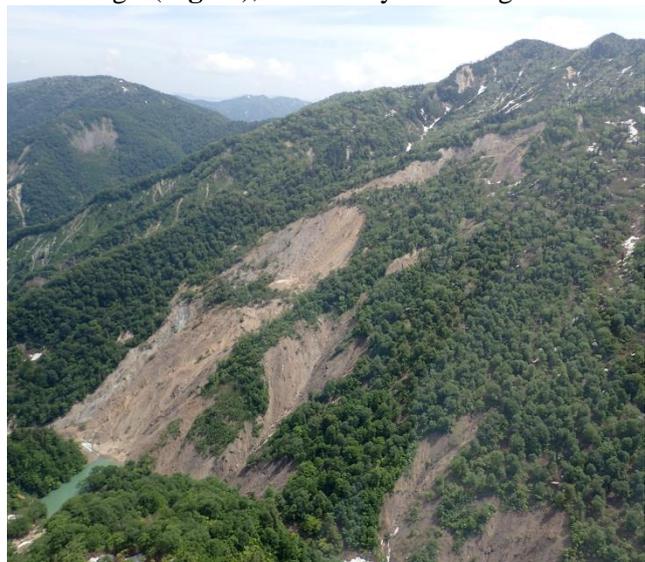
Fig. 1 Whole view of the landslide occurred in May 2015 taken on June 2, 2015 by Ishikawa Forest Management Office.

Fig. 1 shows an overall view of the landslide, which was 800 m long and 300 m wide. The scarp was 400 m long and 300 m wide; the collapse depth was up to 45 m; and the elevation difference was about 400 m. The cross-sectional profiles generated from digital elevation models before and after the landslide are also shown in Fig. 4. A large scarp at

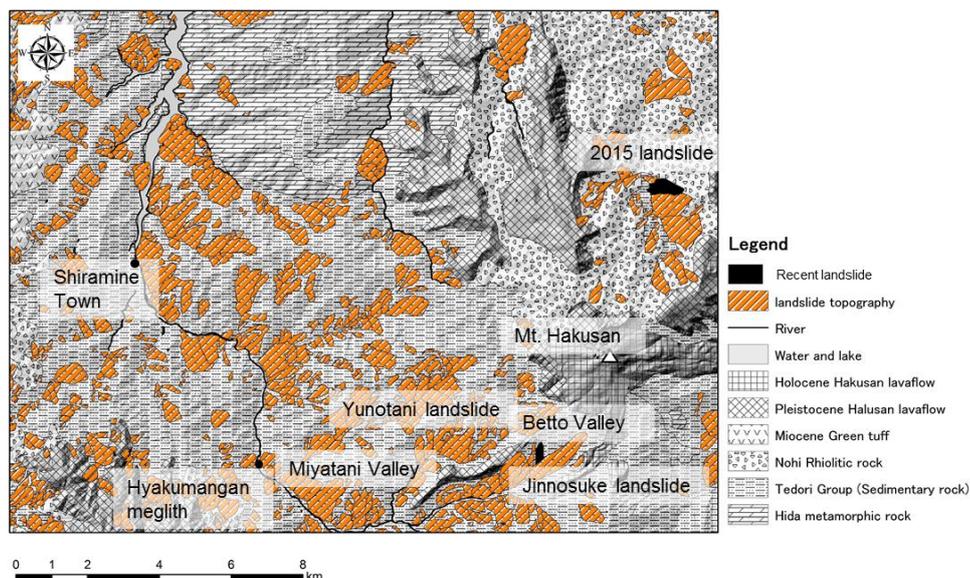
Fig. 3 Geology and landslide topography surrounding the 2015 landslide in Hakusan Mountain Range. Geological data and landslide data were provided by AIST Geological Survey and Integration Center (2016) and Disaster prevention science and technology research institute (2016), respectively.

Mt. Hakusan is located in the headwaters of the Tedoru River basin (Fig. 2). The upstream part of the basin has many steep slopes, and large landslides are common. The geology of the basin ranges from underlying Hida metamorphic rock formed in the Paleozoic to Quaternary volcanic deposits (Fig. 3). The metamorphic rocks include gneiss to the east of the Tedoru River Dam and in the Ozo River sub-basin. The Tedoru group, which is mainly composed of sedimentary rock from the Jurassic to Cretaceous, is distributed upstream in the Tedoru River. The eastern part of the Ozo River basin is Nohi Rhyolitic rock from the Cretaceous to the early Paleogene period. Miocene marine volcanic deposits of green tuff are distributed in the middle reach of the Tedoru basin. New and old Mt. Hakusan volcanic deposits, from eruptions that occurred from the late Pleistocene to the early Holocene, cover the main peak of Mt. Hakusan and associated ridges. The erosion of the volcano has created barren landforms, such as landslides and slope failures, and generated a large amount of sediment. Most of the old landslide topography formed during the last glacial period until the early Holocene (Kojima *et al.* 2015).

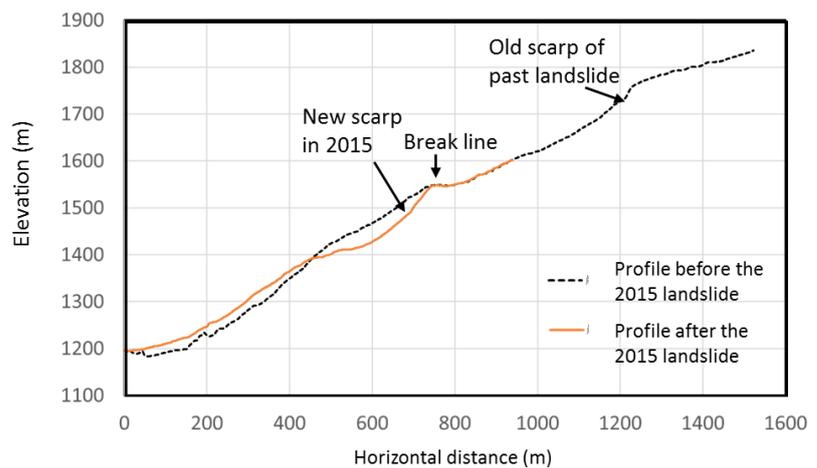
Fig. 4 Longitudinal profile before and after the 2015 landslide.

around 1,700 m in elevation, which was formed by previous movement, already existed and a break line was recognized in the middle slope at 1,500 m. The new scarp formed by the 2015 landslide was located below the break line at 1,390–1,550 m; the collapsed area was 6.4 ha. Before the landslide, an old-growth forest composed of birch (*Betula ermanii*) and beech (*Fagus crenata*) covered an area of 5 ha. However, this forest was destroyed completely by the landslide and buried in the streambed. Some forest slipped down from the upper slope and was retained on the middle slope, which looks as though it has not moved. Nevertheless, many of the tree trunks in this area now tilt in various directions, and most trees were seriously damaged and withered.

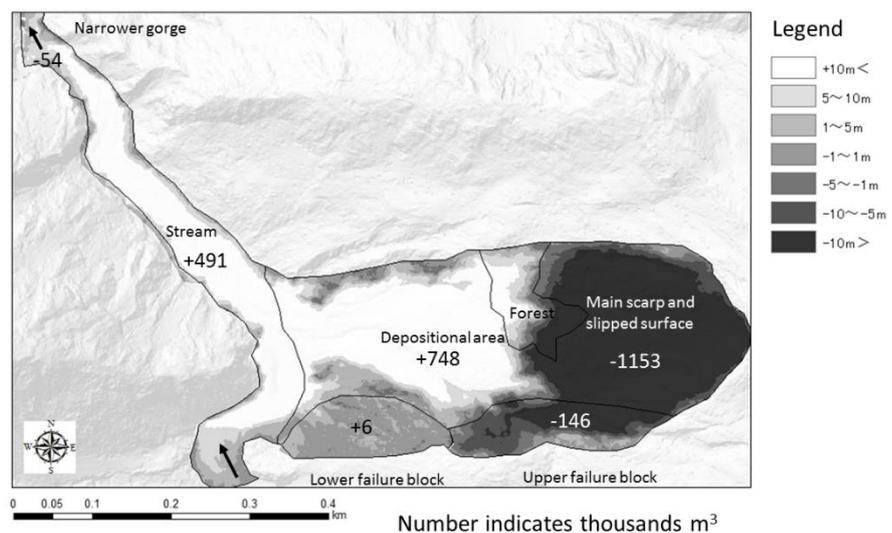
Fig. 5 Elevational change between Oct 2014 and June 2015. The numbers indicate degraded and aggraded sediment volume (thousands m³).

The collapsed sediment covered the original slope up to 500 m from the downstream portion of the slide, which had a maximum thickness of 35 m (mean 11 m) (Fig. 5). The deposited sediment volume was 748,000 m³. There was a narrow gorge 500 m downstream from the bottom of the collapsed slope, and most of the transported sediments were stored there. These sediments created a sand bar about 100 m in width, and the riverbed was raised about 10 m above its original level. The sediment accumulated in the 500-m section from the landslide slope to the gorge had an estimated volume of 491,000 m³. The volume stored on the lower slope and in the stream section was 1.25 million m³, sediment transported farther downstream was 50,000 m³.

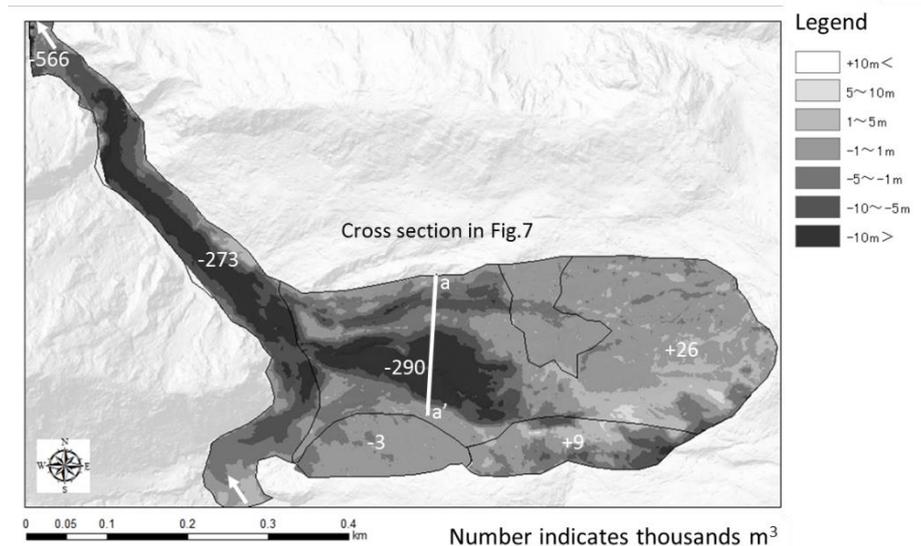
Fig. 6 Elevational change between June and October 2015. The numbers indicate degraded and aggraded sediment volume (thousands m³).

After the landslide, the collapsed deposits (about 750,000 m³) that accumulated on the slope eroded into the stream. Fig. 6 shows the eroded sediment

volume from June 20 to October 2015 determined from the LiDAR data; the denuded volume was also calculated. On the slipped surface in the upper part of slope, the topographical change was slight, and sediment (26,000 m³) supplied from the upper rim of the scarp was retained within the slipped slope. Two gullies, which were buried by the landslide debris, have since been carved out with a large amount of landslide deposits. The estimated amounts of degraded deposits were 290,000 m³ from the slope and 273,000 m³ from the channel; in total 563,000 m³ of sediment flowed downstream.

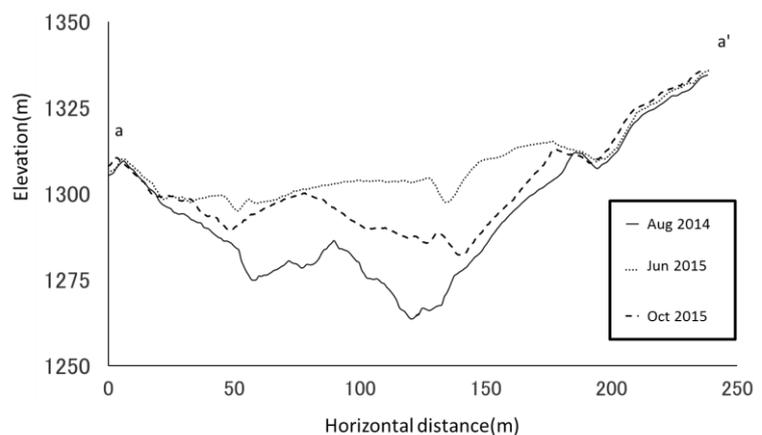
Fig. 7 Cross sections before, just after and a half year later of the 2015 landslide at the bottom of landslide.

In August 2015, the forest management office sprayed mortar on the slide to prevent surface erosion. This material remained on most of the upper slope and on the left and right sides of the lower slope, but none remained in the center of the lower slope, where a deep gully formed. Fig. 7 shows a

cross-section of the lower slope, where the accumulated deposits were deeply incised. In the spring of 2015, just after the landslide, the slope was deeply covered with landslide deposits over a horizontal distance of 200 m. However, this surface changed drastically: within 6 months, a 20-m-deep V-shaped valley had formed in the middle section, and the deposits flowed downstream.

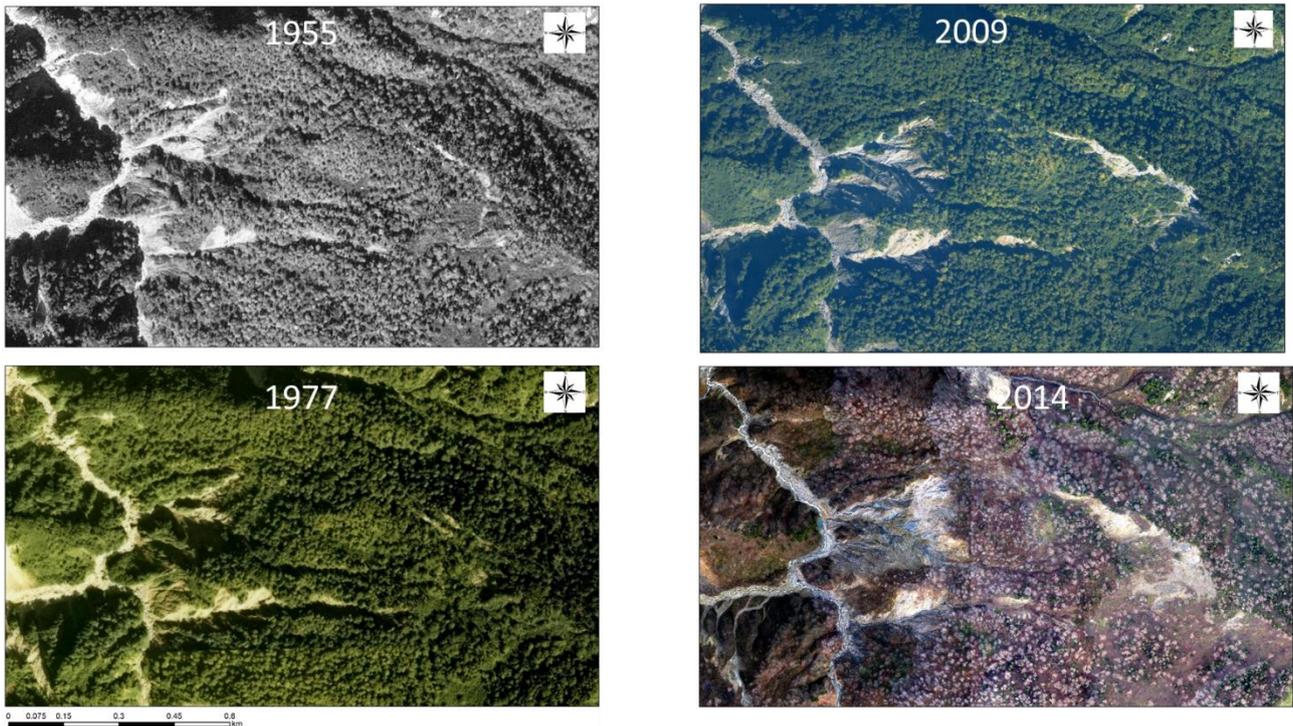
Fig. 8 A series of aerial photos since 1955. Upper left: taken by US Airforce in 1955, Lower left: Color photo taken by Geographical Survey in 1977, Upper right: photo taken by Geographical Survey in 2009 and Lower right: taken by Kanazawa River and National Highway Road Office in 2014.

Several phenomena were regarded as precursors of the landslide. The scarp of the older landslide block is clearly recognized in the oldest photo taken by the US Airforce in 1955 (**Fig. 8**), although it was

not quite as wide as at present. A large bare slope also existed on the bottom of the lower part of the 2015 landslide. A color aerial photograph taken by the Geographical Survey Institute in 1977 shows no initial change compared with aerial photographs taken in 1955. In 2009, this changed dramatically. The crack in the scarp reopened and the area of bare slope along the channel became larger, indicating that the landslide movement had been accelerating since 1977.

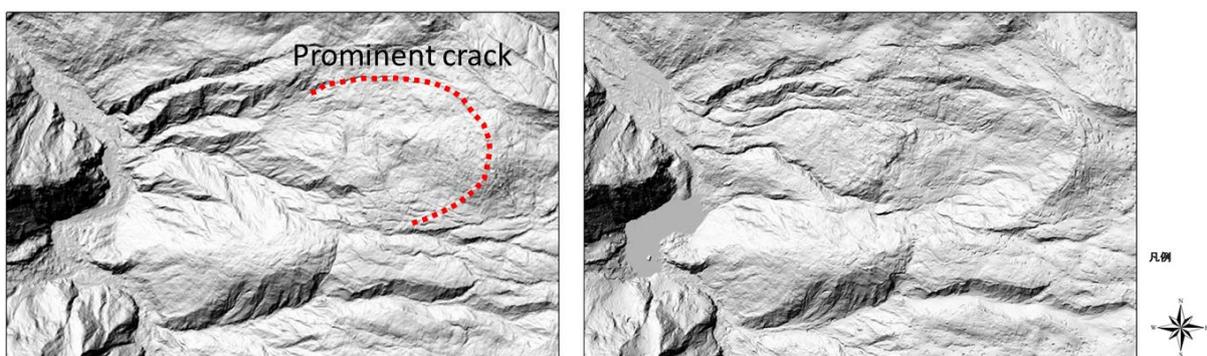
Fig. 9 Micro-topography comparison before (left, November 2014) and after (right, June 2015) the 2015 landslide. Break line indicates boundary of landslide block analyzed by LiDAR data.

prominent, and numerous cracks became visible in the center of the landslide. **Fig. 9** compares the topography before and after the landslide. Before the 2015 landslide, the lower part of the slope had been denuded and bedrock was exposed, while the upper part of the slope had been torn by many arc-shaped cracks. The crack shown by the dashed line was prominent, and this coincided precisely with the scarp of the 2015 landslide. This implies that the landslide had already begun moving before 2015. Therefore, it should be possible to predict where a landslide will occur by searching for such microtopography.

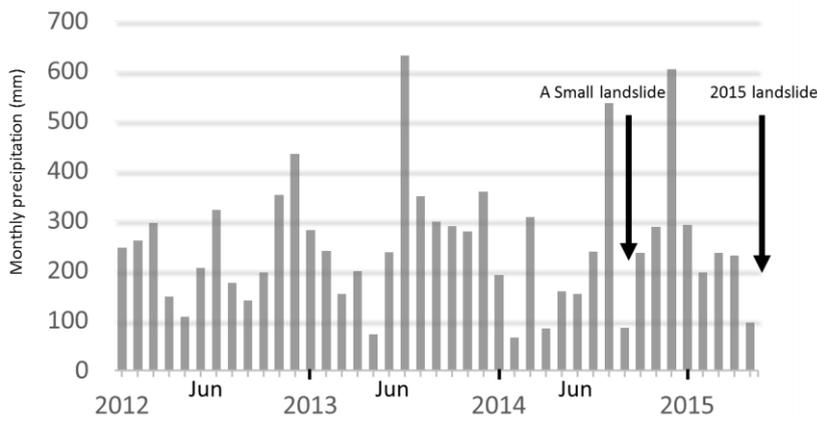
Fig. 10 Monthly precipitation from 2012 to 2015 before the landslide at Shiramine weather observation point.

landslide were analyzed using AMeDAS data. **Fig. 10** shows the monthly maximum rainfall over the past 4 years in Shiramine, Hakusan. High rainfall occurred in the period from 2013 to 2014 and the monthly precipitation in July 2013 was 630 mm. This intense rainfall caused serious flooding damage downstream in the Tedoru River. In 2014, torrential rain also occurred, with monthly rainfall of 535.5 mm and hourly rainfall of 29 mm. After this rainfall event, a small slope failure that presaged the 2015 landslide occurred at the lower end of the landslide area. The amount of

snowfall in the winter of 2014 was high and the monthly precipitation in December reached 603 mm. The 2015 landslide was very likely caused by melting of the snowfall that accumulated on the slope in December 2014.

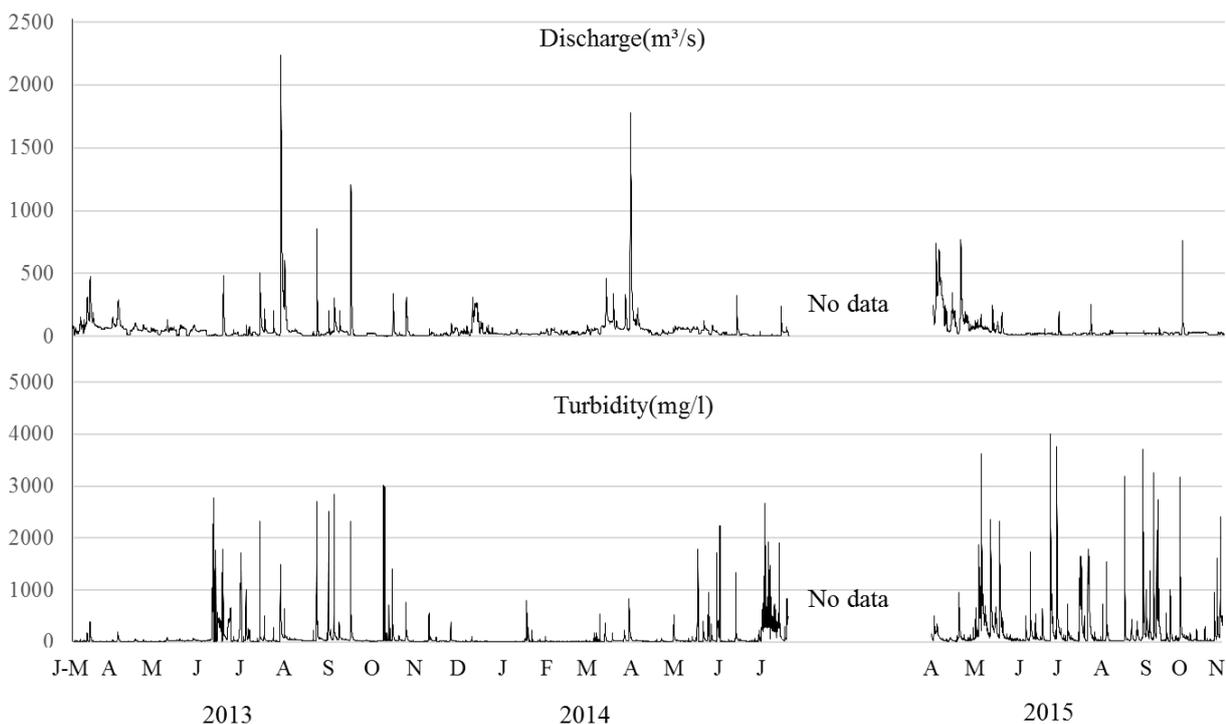
Fig. 11 Discharge and turbidity from 2013 to 2015 at Tsurugi gaging station.

channel of the Tedoru River. **Fig. 11** shows the turbidity and discharge over the 3 years from 2013 to 2015 measured at Tsurugi gaging station. Turbidity exceeding 2,000 mg/l was observed once in 2013, but not in 2014. In comparison, turbid discharge exceeding 2,000 mg/l occurred frequently after May 2015, and a peak turbidity exceeding 4,000 mg/l was recorded in June when the discharge was the lowest. During the summer, turbidity tends to increase when the rainfall exceeds 40 mm, and the peak turbidity in June was recorded when rainfall exceeded 80 mm.

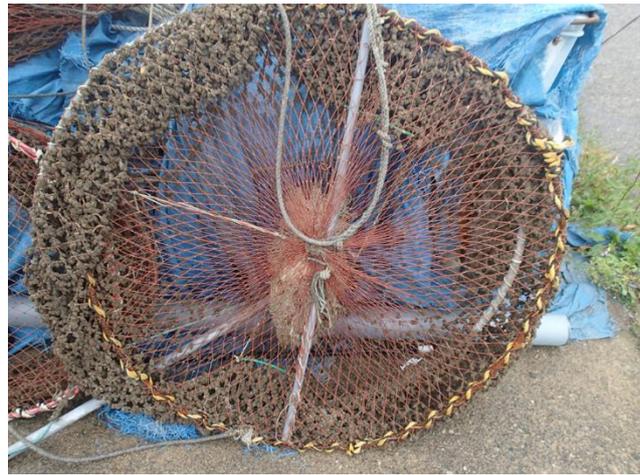
Fig. 12 Fine sediment adhered with Squid fishing net.
