Extreme Torrential Flooding at Simbach on June 1st, 2016 - Key Findings of a Detailed Event Analysis -

Andreas RIMBÖCK^{1*}, Johannes HÜBL² and Rainer HÖHNE¹

¹ Bavarian Environment Agency (Bürgermeister-Ulrich-Straße 160, 86179 Augsburg, Germany)

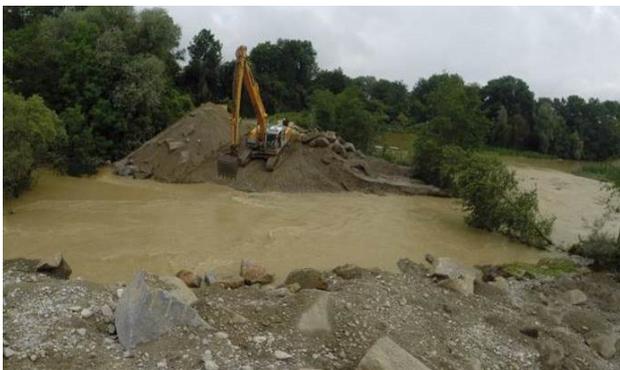
Fig. 2 Artificial levee breach (Source: VERBUND Innkraftwerke GmbH)

water. As a result large quantities of water were flowing through the center of Simbach. The dykes along the torrent were overflowed and the left one to the Polder Erlach (at Wilhelm-Dieß-Straße) eventually breached. More than two million cubic meters water accumulated in both polders together (**Fig. 1**). Due to the levees along the Inn the water could not drain into the receiving stream, which at that time was not prone to flooding. The pumping stations were overburdened by the extreme amounts of water. To relief the polder Erlach a levee was opened temporarily (**Fig. 2**). In addition mobile pumps were used.

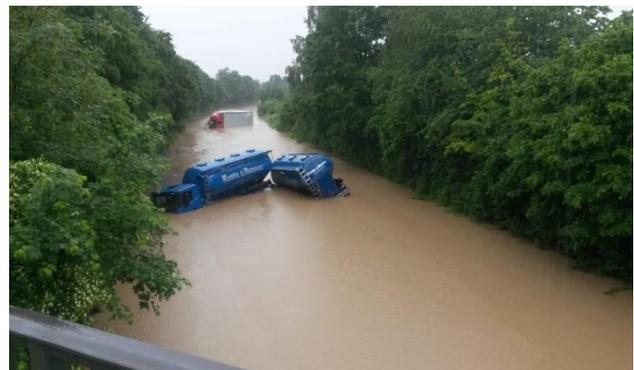
Fig. 3 Flooded federal road B12 (Source: Polizei Niederbayern)

The event caused very high damages. Besides the high damage to property five casualties were to be mourned. A lot of people had to be evacuated or rescued from acute danger to life. Several citizens could not return to their homes due to danger of collapse. Fresh water supply and waste water disposal was limited and partly broken down. Important traffic routes were interrupted causing major traffic problems (**Fig. 3**).

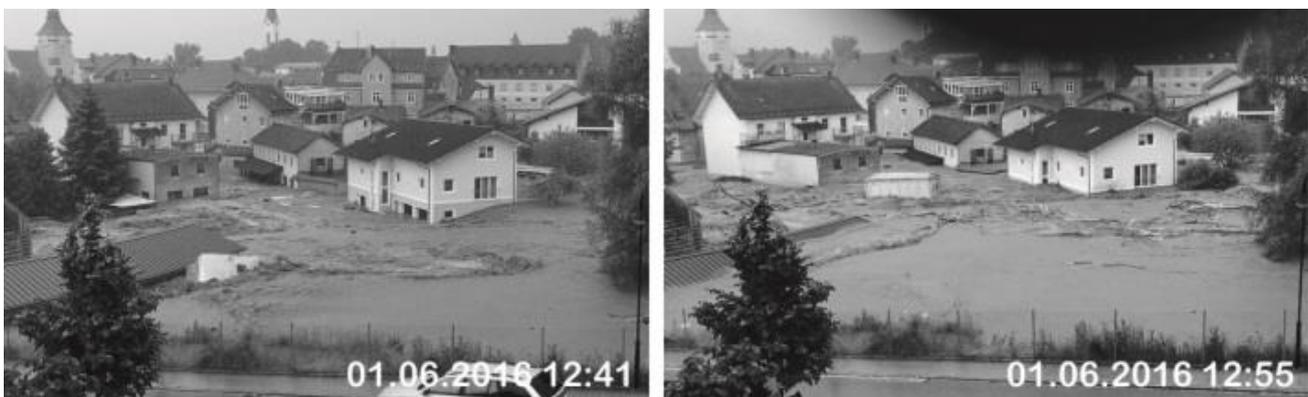
Fig. 6 Discharge at the upper end of the channel through the town about 120 meters upstream of the gauging station. Natural runoff (left) just before the arrival of the breaching surge (right) (Source: Köck)

dynamics at different sites and to detect the time of dam failures, nearly thousand photos and more than 60 videos were analyzed and the time record of the pictures determined by individual inquiry (**Fig. 6**). Additional water marks were surveyed in the flooded areas to ascertain the flow height at different locations and to later compare these values with the results of the hydraulic simulation.
