Topographical Changes Due to Heavy Rainfall in the Chiu-Fen-Erh-Shan Landslide Triggered by the Chi-Chi Earthquake in Taiwan

This paper reports on topographical changes in the sediment area in the Chiu-fen-erh-shan landslide located in Nantou County, central Taiwan. This landslide was triggered by the Chi-Chi earthquake ($M_L = 7.3$) on September 21st, 1999. Field work-surveys conducted from 1999 immediately after the earthquake, to 2005. This landslide is a huge dip-slope slide, and about 1 km wide, 2 km long and 80m deep. The landslide buried several valleys on the lower slope, reaching a maximum depth of about 80m, and yielding four natural dams. The maximum depth of the water in these dams reaches about 30m. After the Chi-Chi earthquake, the heavy rainfalls accompanying the Toraji and the Nari typhoons in 2001 followed by the Mindulle and the Aere typhoons in 2004, greatly changed the topographical features of the landslide sediment area. The most dramatic changes in the sediment area mainly occurred along a main spill way which was constructed as a countermeasure against flooding. Groundsel and revetment works were severely damaged due to these changes. In particular, downstr

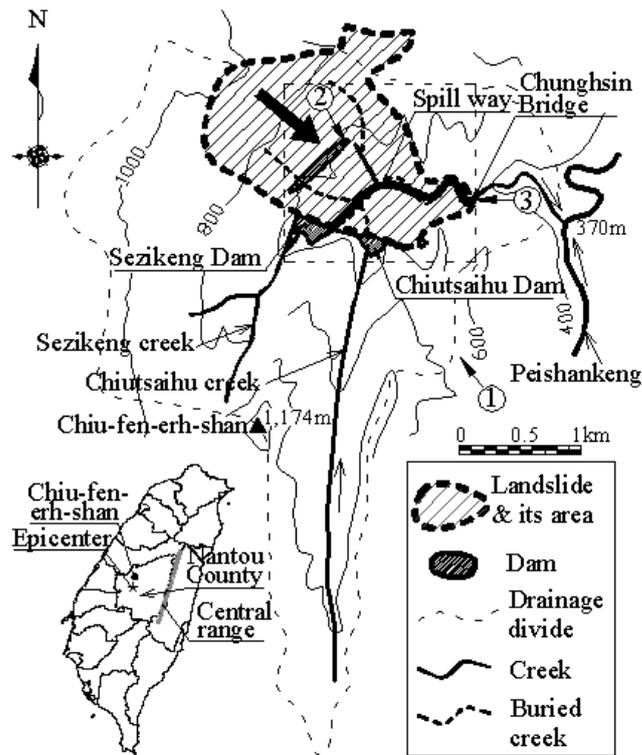
Fig. 1. Outline figure of the Chiu-fen-erh-shan landslide

The Chue-fen-erh-shan landslide (hereafter referred to as the main landslide) occurred at the southeast slope of the Chiutsaihu basin. The main landslide has an average width of about 1 km, a length of about 2 km, an area of about 195 hectares and a sediment volume of about 35 million cubic meters (Hayashi *et al.*, 2004). The depth of the slip surface of the main landslide reached a maximum size of about 74 m, with an average size of about 45 m (Hayashi *et al.*, 2003). The average angle of inclination is 22 degrees at the upper part of the slope and 27 degrees at the lower part of the slope (Kondo *et al.*, 2001). The basin of the Chiutsaihu creek exhibits a slender shape influenced strongly by an axis of syncline in a north-south direction, as shown in Fig.1. The Soil and Water Conservation Bureau of Taiwan has constructed countermeasures such as a spill way, groundsel works, and revetment works to combat the erosion of sediment area caused by water flow over the natural dams.

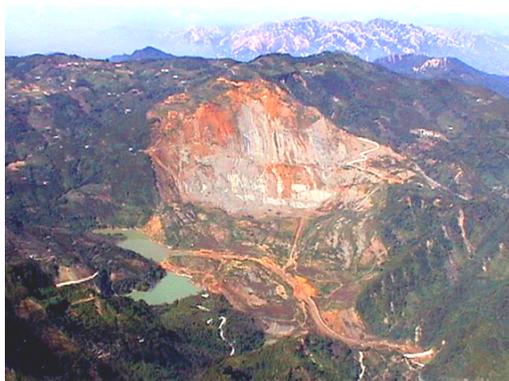
Photo. 1. View of the Chiu-fen-erh-shan landslide (taken on Dec. 17, 2000)

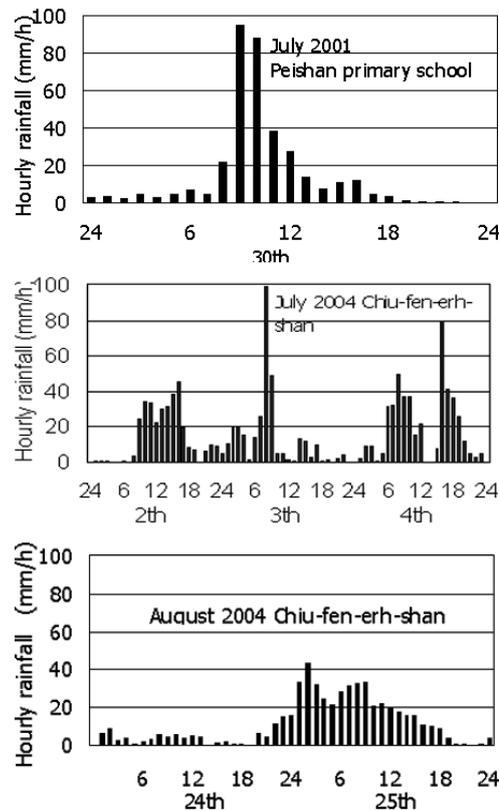
Fig. 2. Main rainfalls causing degradation, sedimentation and landslide in the sediment area

Several topographical changes such as degradation, sedimentation and landslide in the sediment area after the Chi-Chi earthquake were caused mainly by heavy rainfall in 2001 and 2004. Though the Nari typhoon during the 16th to 19th, September, 2001 did not bring much precipitation, the Toraji typhoon during the 29th to 30th, October, 2001 produced heavy rainfall over the Chue-fen-erh-shan district, as shown in Table 1 and Fig.2. The precipitation station located at the Peishan primary school far about 6 kilometers north-northeast of the main landslide, recorded a maximum hourly rainfall of 95.0 mm and daily rainfall of 357.5 mm during the Toraji typhoon. The heavy rainfalls brought by these typhoons caused much damage throughout Taiwan (Kondo *et al.*, 2003). In 2004, the Mindulle typhoon during the 1st to 5th, July brought a maximum hourly rainfall of 98.5 mm and an accumulated rainfall of 1,158 mm at the monitoring station of the Chiu-fen-erh-shan district, which was founded after the occurrence of the main landslide. The event caused by this heavy rainfall is called the 72 Water Induced Disaster in Taiwan. Following this, the Aere typhoon during the 23rd to 25th, August brought a maximum hourly rainfall of 43.5 mm and an accumulated rainfall of 430 mm at the same monitoring station. This typhoon also struck Taiwan directly.

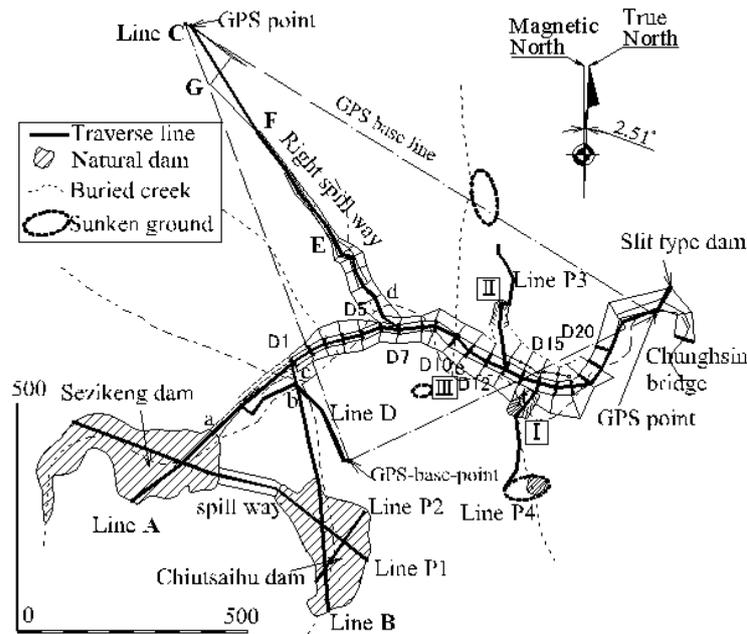
Fig. 3. Plan based on survey

The plan which was drawn based on the survey is shown in Fig.3. The location of this plan throughout the basin area of the Chiutsaihu creek is indicated in Fig.1 by a square of broken line. In this plan, the suffix 'D' indicates a numeral of the groundsel works constructed of concrete piles. Numeral suffixes are numbered from upstream to downstream. Broken lines indicating buried creeks are drawn based on a topographical map

In Fig.4, the average stream gradient having around $1/7.1$ from D1 to the Chung-hsin bridge, decreased to $1/12.0$ as influenced by 21 groundsel works. The groundsel works as countermeasure to prevent degradation are composed of concrete piles 1 m in diameter staggered in arrangements of 3 rows on concrete footings 1.8 m thick and 7 m wide. The piles are driven into a foundation from the bottom of the footing to protect subsidence and to maintain bearing capacity. Clearances between the piles are filled by boulders. The dam at the downstream edge (on the right upstream of the Chung-hsin bridge) in Fig.3 has a slit type gravitational concrete structure.

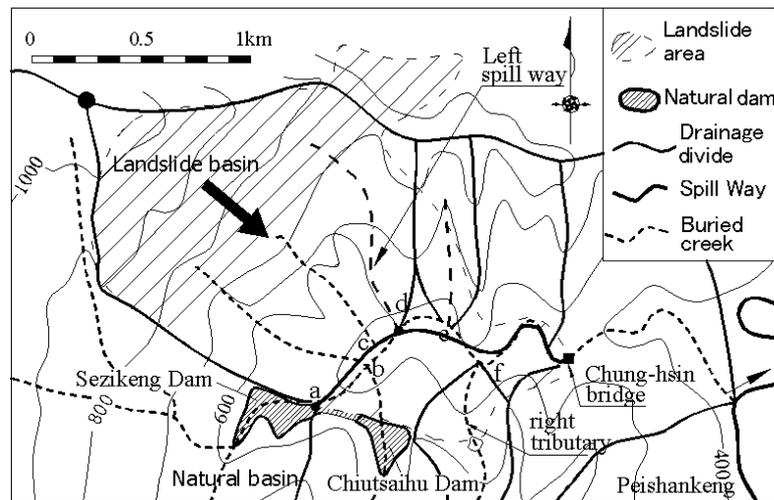
Fig. 7. Outline of the buried creek and its basin

The whole of the basin area of the Chiutsaihu creek is 10.6 km^2 . The relative height from the peak of the Chue-fen-erh-shan mountain to the confluence with the Peishankeng river downstream of the Chiutsaihu creek is about 800 m. The slopes in the basin, in general, are steep but are relatively gentle in the upper part of the slopes near the watershed divide. The Chiutsaihu creek before the occurrence of the main landslide met with the Sezikeng creek at point b in Fig.7 (Fig.3).

The main landslide caused by the earthquake had occurred in the basins flowing into the Chiutsaihu creek at points b, c and d. By the occurrence of the main landslide, rain water in all these basins began to flow into the main spill way at point d (D7) through the left spill way. The main landslide area almost covers these basins. Throughout the whole basin consisting of the dip slope, the terrain is exposed rock, thus, rain water quickly runs off as surface flow. This basin could be called the “landslide basin” (area = 1.40 km²).

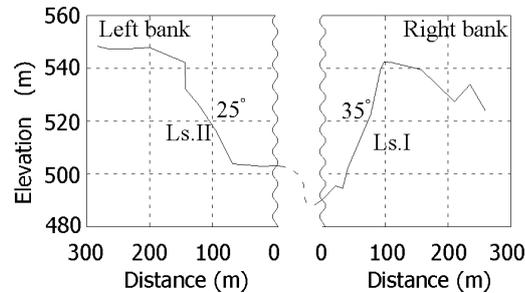
Fig. 9. Longitudinal figure of Ls. I (left of D13) and Ls. II (right of D15)

the buried creek cannot be clearly seen behind Ls. III, the configuration of the valley before the main landslide occurred can be distinguished in the map 1/ 25,000 in scale. Sunken ground indicated in the figure as a circle, can be seen after the main landslide due to the influence of old topographical features. In this manner, the landslides along the main spill way which occurred along the slope, correspond with buried creeks and old configuration of the valley where sunken grounds exist. The landslides along the main spill way have been creating their original own basin as is illustrated in Fig.7. Water from heavy rainfall concentrates in these places even after the topographical configuration of the creek and valley have been buried by landslides. Water seepage into the sediment area of the main landslide easily flows into the buried Chiutsaihu creek located at the main spill way, as was restricted by the old configuration. The seepage of water generated a slope that is susceptible to landslides.
