Characteristics of Slope Failure Induced by the Mid Niigata Prefecture Earthquake and the Snow Melting after the Snow Term

Kazuya Akiyama,¹⁾ Jun-ichi Kurihara²⁾ and Kiichiro Ogawa³⁾

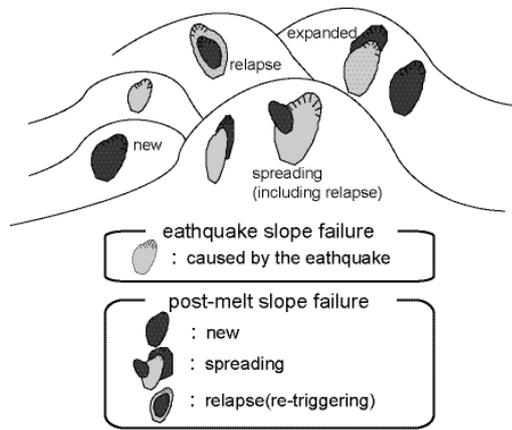
Fig. 2. Classification of slope failures

Post-melt slope failures were further divided into three categories according to the relationship to the initial earthquake slope failure, as shown in Figure 2.

1. New: slope failures occurred on the outside of earthquake slope collapses

2. Spreading: slope failures spreading in head or side part of previous failure by the earthquake
3. Relapse (re-triggering): collapse of internal section (rupture surface) of earthquake slope collapse

The third type of slope failure (relapse) tends to involve failure to a greater ground depth but little or no increase in surface area.

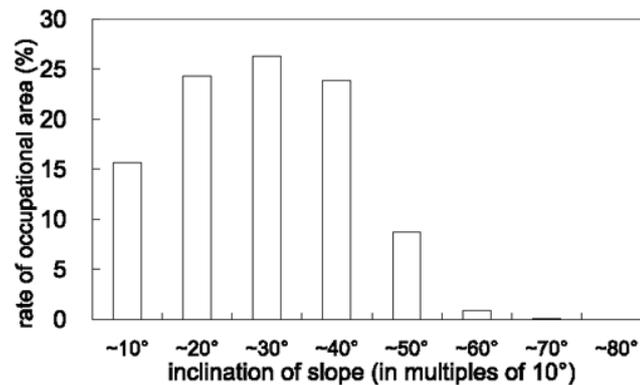
Fig. 3. Relative proportion of slope inclination in the Imo River basin

The inclination of slopes in the river basin area was analyzed by calculating the number of 5 m meshes in each inclination category (in multiples of 10°) and multiplying this by the lattice area to determine the relative proportion of each category within the river basin as a whole. The same approach was used to calculate the respective proportions of slope failures caused by earthquake and snow within each inclination category. The inclination of a slope failure region after earthquake was defined as the angle between the horizontal plane and a straight line drawn between the highest and lowest points within the region. Figures 3 and 4 show the results. Most slopes in the Imo river basin have an inclination of between 10° and 40°. Within slope failure regions, failures caused by earthquake were most common at slope inclinations in the range 30°–50°, which is virtually equivalent to the inclination most vulnerable to earthquake (as shown in Table 1). However, earthquake slope failures also occurred in locations with lower inclination in the range lower than 30°. Failures caused by snow were most common at slope inclinations in the range 40°–50°. Thus, inclination of slope failure caused by snow is higher than by rainfall (as shown in Table 1), and overlaps the range for earthquake, suggesting that the earthquake has had an effect on the slope failures due to snow.
