A FLOOD RETENTION BASIN IN AN ABANDONED STONE QUARRY - EVALUATING THE STABILITY OF A SUBMERGED ROCK SLOPE

ABSTRACT

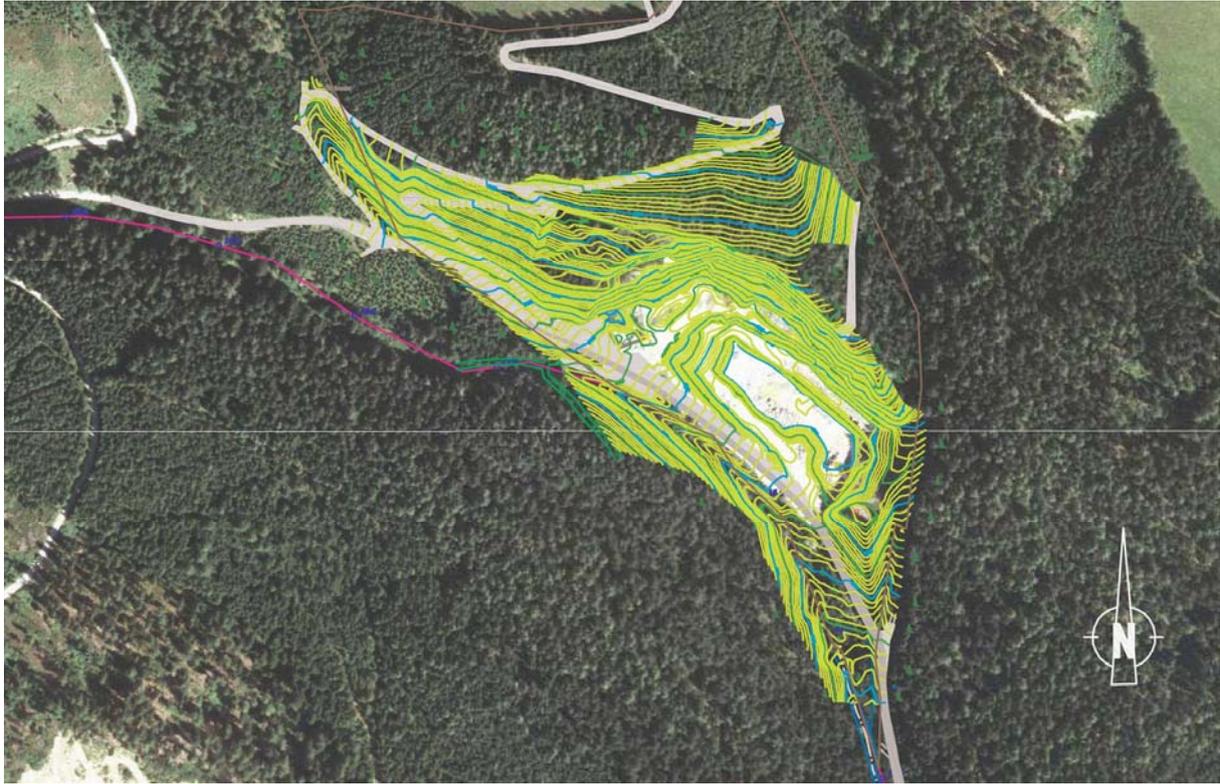
Fig.2 Orthofoto of the stone quarry with 1m-contour lines

The quarrying activities have left a steep rock slope with an inclination of 60°. The slope's foot is located at 609 m a.s.l. The slope would be submerged up to 622 m a.s.l. for several days when the flood retention basin is filled. Extensive geological and geotechnical investigations and simulations were realized to prove the stability of this slope during submersion.

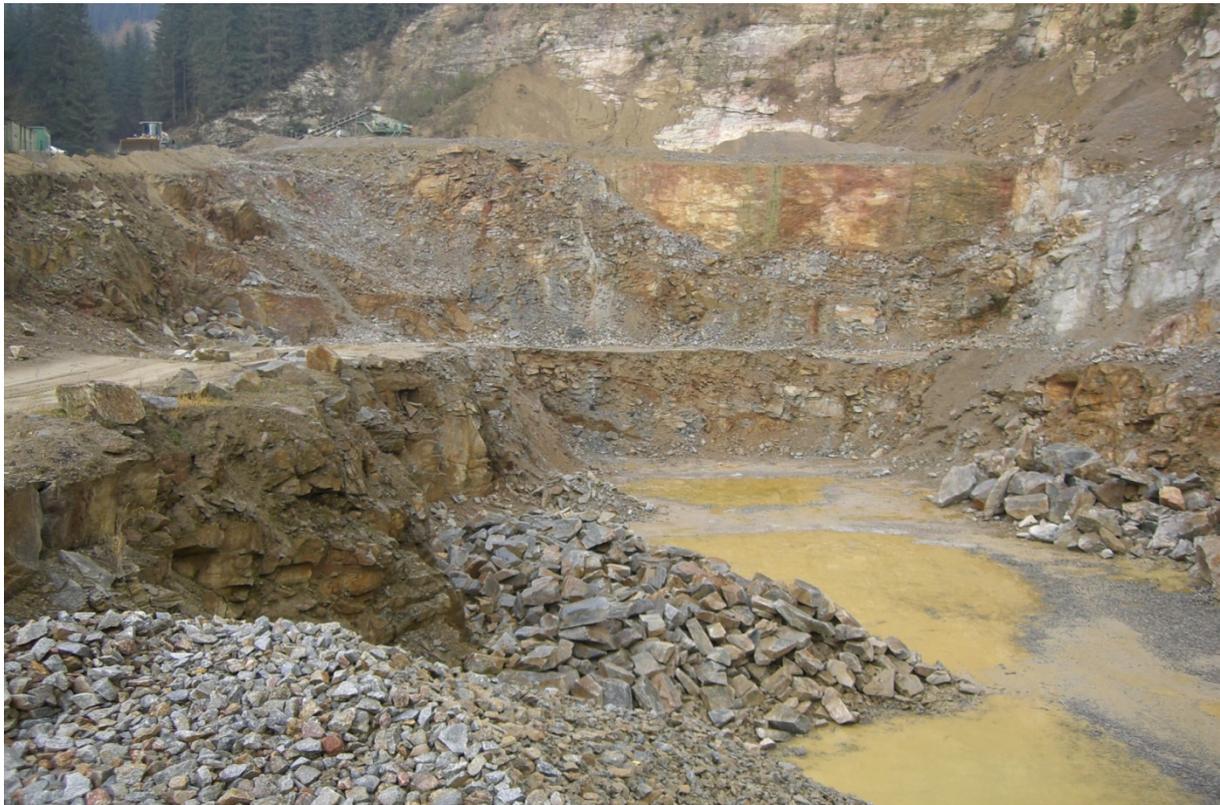
Fig.3 Stone quarry next to the left bank of Lammerbach (viewing direction northwest)

A stone quarry located upstream of the alluvial cone next to the left bank of the torrent is scheduled for shut-down by 2011. The basin of this quarry was thought to be an ideal location to construct a flood retention basin matching the required volume.

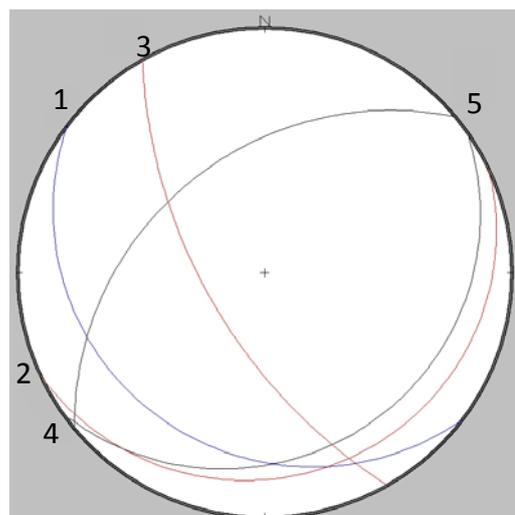
The rock slope was mapped geotechnically and the orientation as well as the conditions of the joints (e.g. roughness) were determined by means of statistical measurements of structural elements (joints and faults) and a photogrammetric analysis using digital pictures of the rock-face (ShapeMetrix). 1 foliation plane, 2 joint sets and 2 faults were identified.

Fig.5 (right) Stereonet with great circles of foliation (1, blue), relevant joints (2 and 3, red) and faults (4 and 5, black)
