The History of Sediment Disasters and Sabo Projects in the Yomase River Basin, Nagano Prefecture, Japan

Key words: Historical sediment disaster, Sabo projects history, Historical sabo facilities, Dry masonry dams

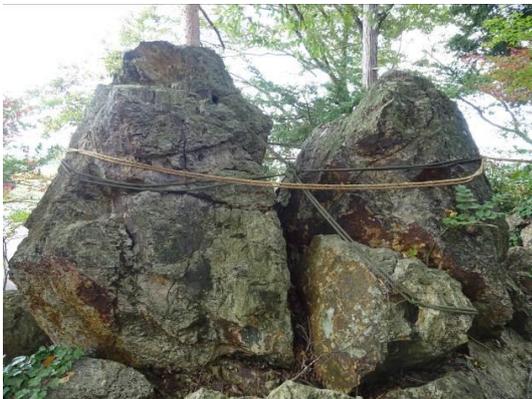
Fig. 5 Boat-mooring stones in the compound of Takaifunatsuki Shrine (Fig. 4, Historical ruins related to sediment disasters ①)

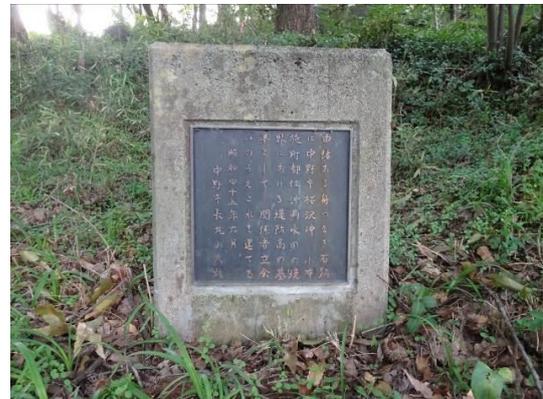
Fig. 6 Remnants of a boat-mooring stone of Sakurasawa (Fig. 4, Historical ruins related to sediment disasters ②)

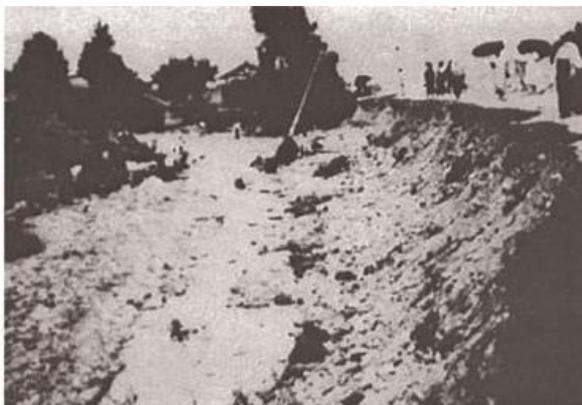
Fig. 12 Dike breach

A torrential rainfall in August 1950 caused a flash flood and burst the dike on the left bank of the Kakuma River. Debris entered into the Honami Hot Spring, killing six people and destroying many buildings and cultivated land (**Fig. 9 to 13**).

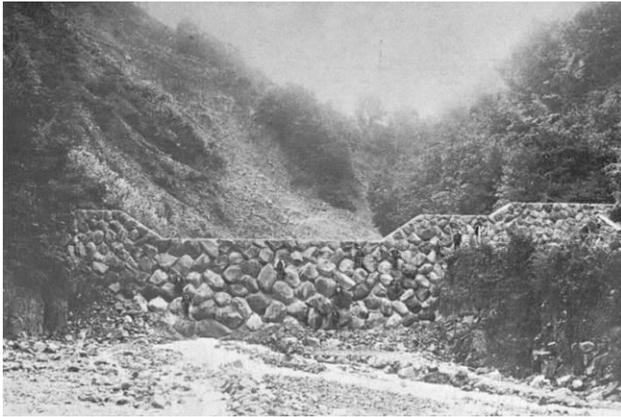
Fig. 15 No. 28 Sabo Dam of the Yomase River
(constructed in 1924)

The No. 34 and No. 28 Sabo Dams, constructed as

a direct project of the national government, were constructed as wet masonry dams at locations where dry masonry sabo dams had been constructed in the Meiji Period. These two dams still remain today (Fig. 15 and 16).
