# Four severe flood events within 11 years - measures and results of the flood risk management in the Free State of Saxony (Germany)

Petra Walther, Dipl.-Hydrologe<sup>1</sup>; Stefan Dornack, Dr.-Ing.<sup>2</sup>; Uwe Müller, Dr.-Ing. habil.<sup>3</sup>

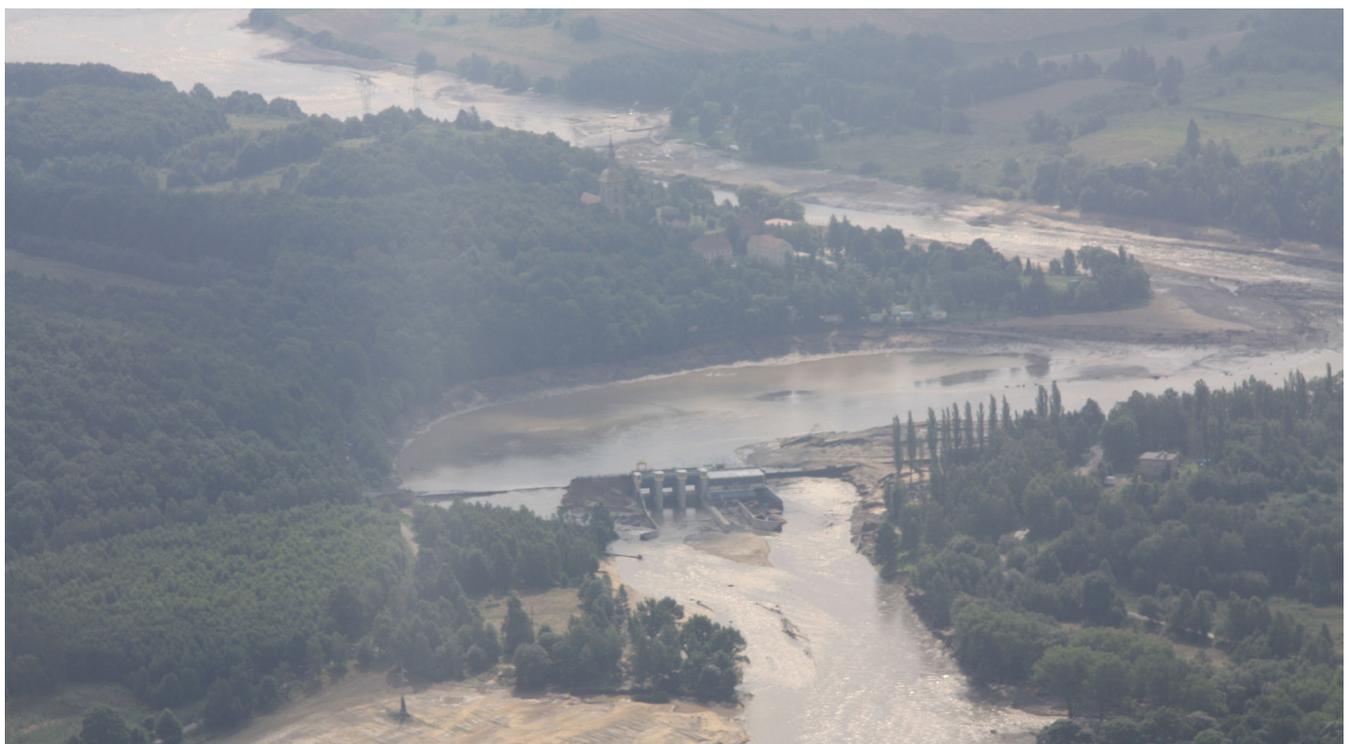
Figure 1. The valley of the river Witka with the broken embankment of the reservoir Niedów (Photo: SMI)

potential reduction. In case studies, particular events are described and analysed in detail to draw conclusions for the future. Such events are for example the damn break in Glashütte in August 2002, the destruction of the water reservoir Niedów at the Witka River in August 2010, the control and the retention of the flood around the city of Leipzig in June 2013 and the consequences of the flooding of the open-mining lakes by the flood as it happened in 2010 and 2013. Further, the flood event management and the flood message service are also analysed. For the first time, social networks represented a new experience concerning the flood defence in 2013 in Saxony. And such networks will play an important role in the future.
