Large wood and sediment retention in the Rienz above the city of Bruneck (South Tyrol)

Sandro Gius, Phd.¹; Martin Moser, Phd.¹; Bruno Mazzorana, Dr.¹; Sabrina Margarete Horak, Phd.¹

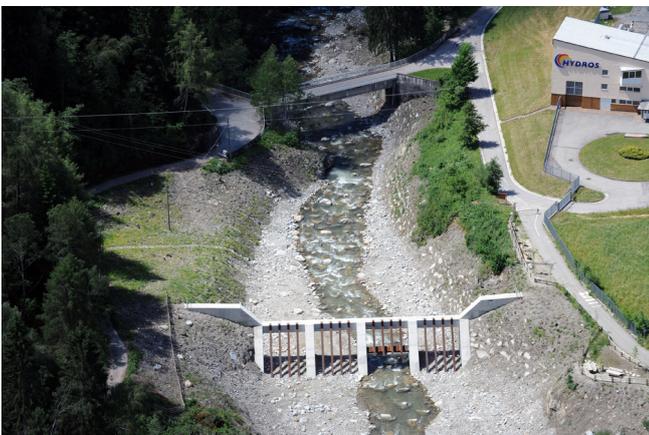
Figure 1. The picture shows from above the large wood retention check dam at Perca just upstream the gorge, with the re-established river continuum, crucial for fish migration.

An open check dam with wood retention function was conveniently built where the river plan form changes from comparably wide to narrow and incised with the objective to meet two fundamental requirements: (I) the spatial separation of sediment and wood in the retention area and (II) a convenient distance from the main settlement areas (i.e. city of Bruneck).

Downstream of the structure the continuity with respect to fish migration was re-established by removing an old check dam (height of 6m) adapting the longitudinal profile accordingly. Whereas the river bed was lowered in the upper part, in the lower part the stream bed was raised by 4 m along a segment of 200 m with respect to the original setting, thereby establishing an average slope of 3,5%. Through an irregular insertion of big cyclopic boulders in the bed river (up to 10 t/ stone) it was possible to provide stream bed stability and morphological variability with irregular forms shaped by stones (up to 1 m).

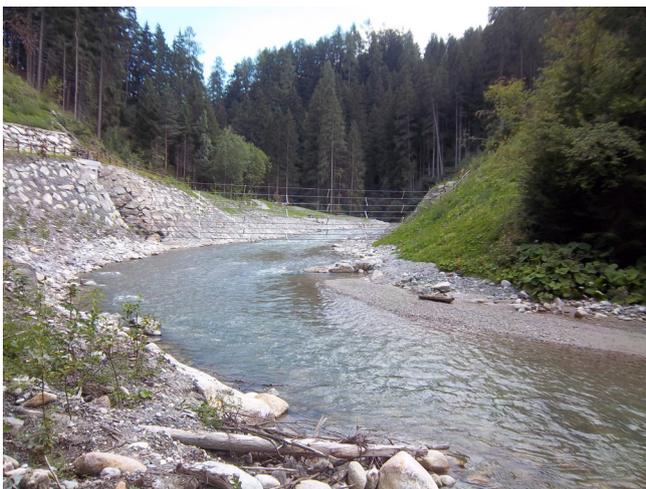
Figure 2. The picture puts in evidence the great landscape compatibility of the cable-filter dam

To check also the large wood (ca. 1800 m³) generated in the whole incised river segment directly upstream of the city, a cable-filter dam (ca. L=50 m, H=7 m) was built.

The decision for this type of structure was made for its good integration into the existing landscape.

After the conclusion of the construction works - apart from riparian stabilization - the cable structure itself is slightly visible.

The two abutments made of concrete, on which the steel cables are fixed, are anchored through 18 anchorages (Ø75 mm) with a length of 21 m in the hillside.
