# The extraordinary handling of the Val Parghera debris flow

Magnus Rageth, Forsting.<sup>1</sup>; Christian Wilhelm, Dr.<sup>1</sup>

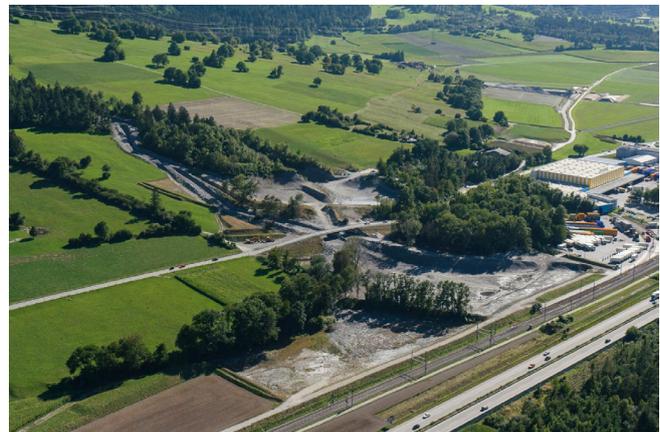
Figure 1. Temporary debris dam in the area of Purchera, Domat/Ems with the endangered traffic carrier and the controlled storage site in the background (Photo: AWN Graubünden).

Domat/Ems. The embankment was immediately breached to redirect the debris flow across the main road onto farmland. During the first couple of months, neither the activity of the landslide nor of the debris flow decreased. To handle the continuous events new embankments were built. The new basin was respectively filled up within a short time and had to be cleared out in an emergency undertaking (Fig.1). To save buildings and infrastructure
